B-B' GEOLOGIC CROSS SECTION
	FIGURE 5

GROUNDWATER ELEVATIONS 07/19/00
	FIGURE 6

GROUNDWATER ELEVATIONS
12/26/01
FIGURE 7

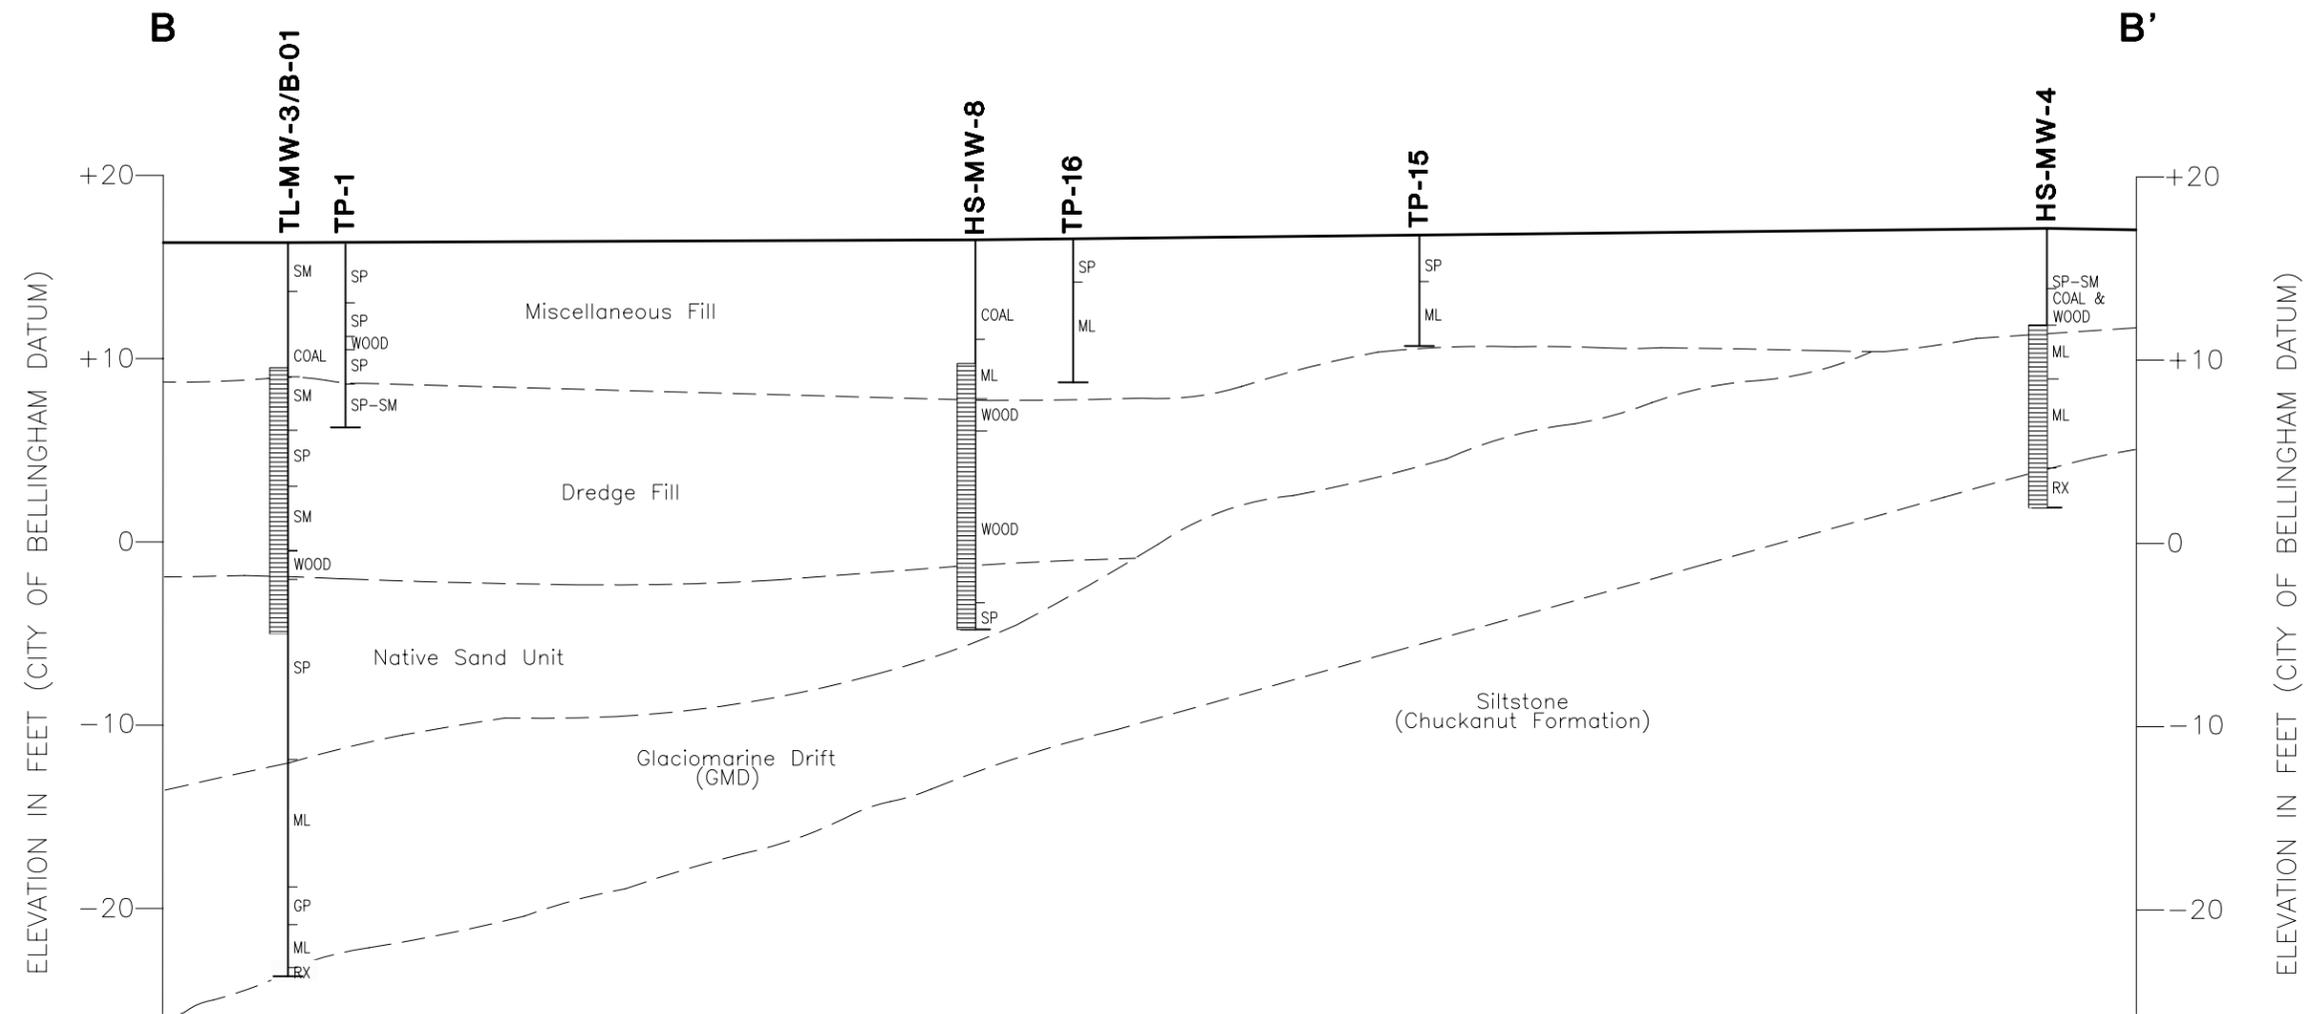
- Notes:
1. The locations of all features shown are approximate.
 2. See GeoEngineers' report entitled "Interim Cleanup Action Plan," dated July 6, 2000 for details concerning the explorations shown on this figure.
 3. This figure is for informational purposes only. It is intended to assist in the identification of features discussed in a related document. Data were compiled from sources as listed in this figure. The data sources do not guarantee these data are accurate or complete. There may have been updates to the data since the publication of this figure. This figure is a copy of a master document. The master hard copy is stored by GeoEngineers, Inc. and will serve as the official document of record.

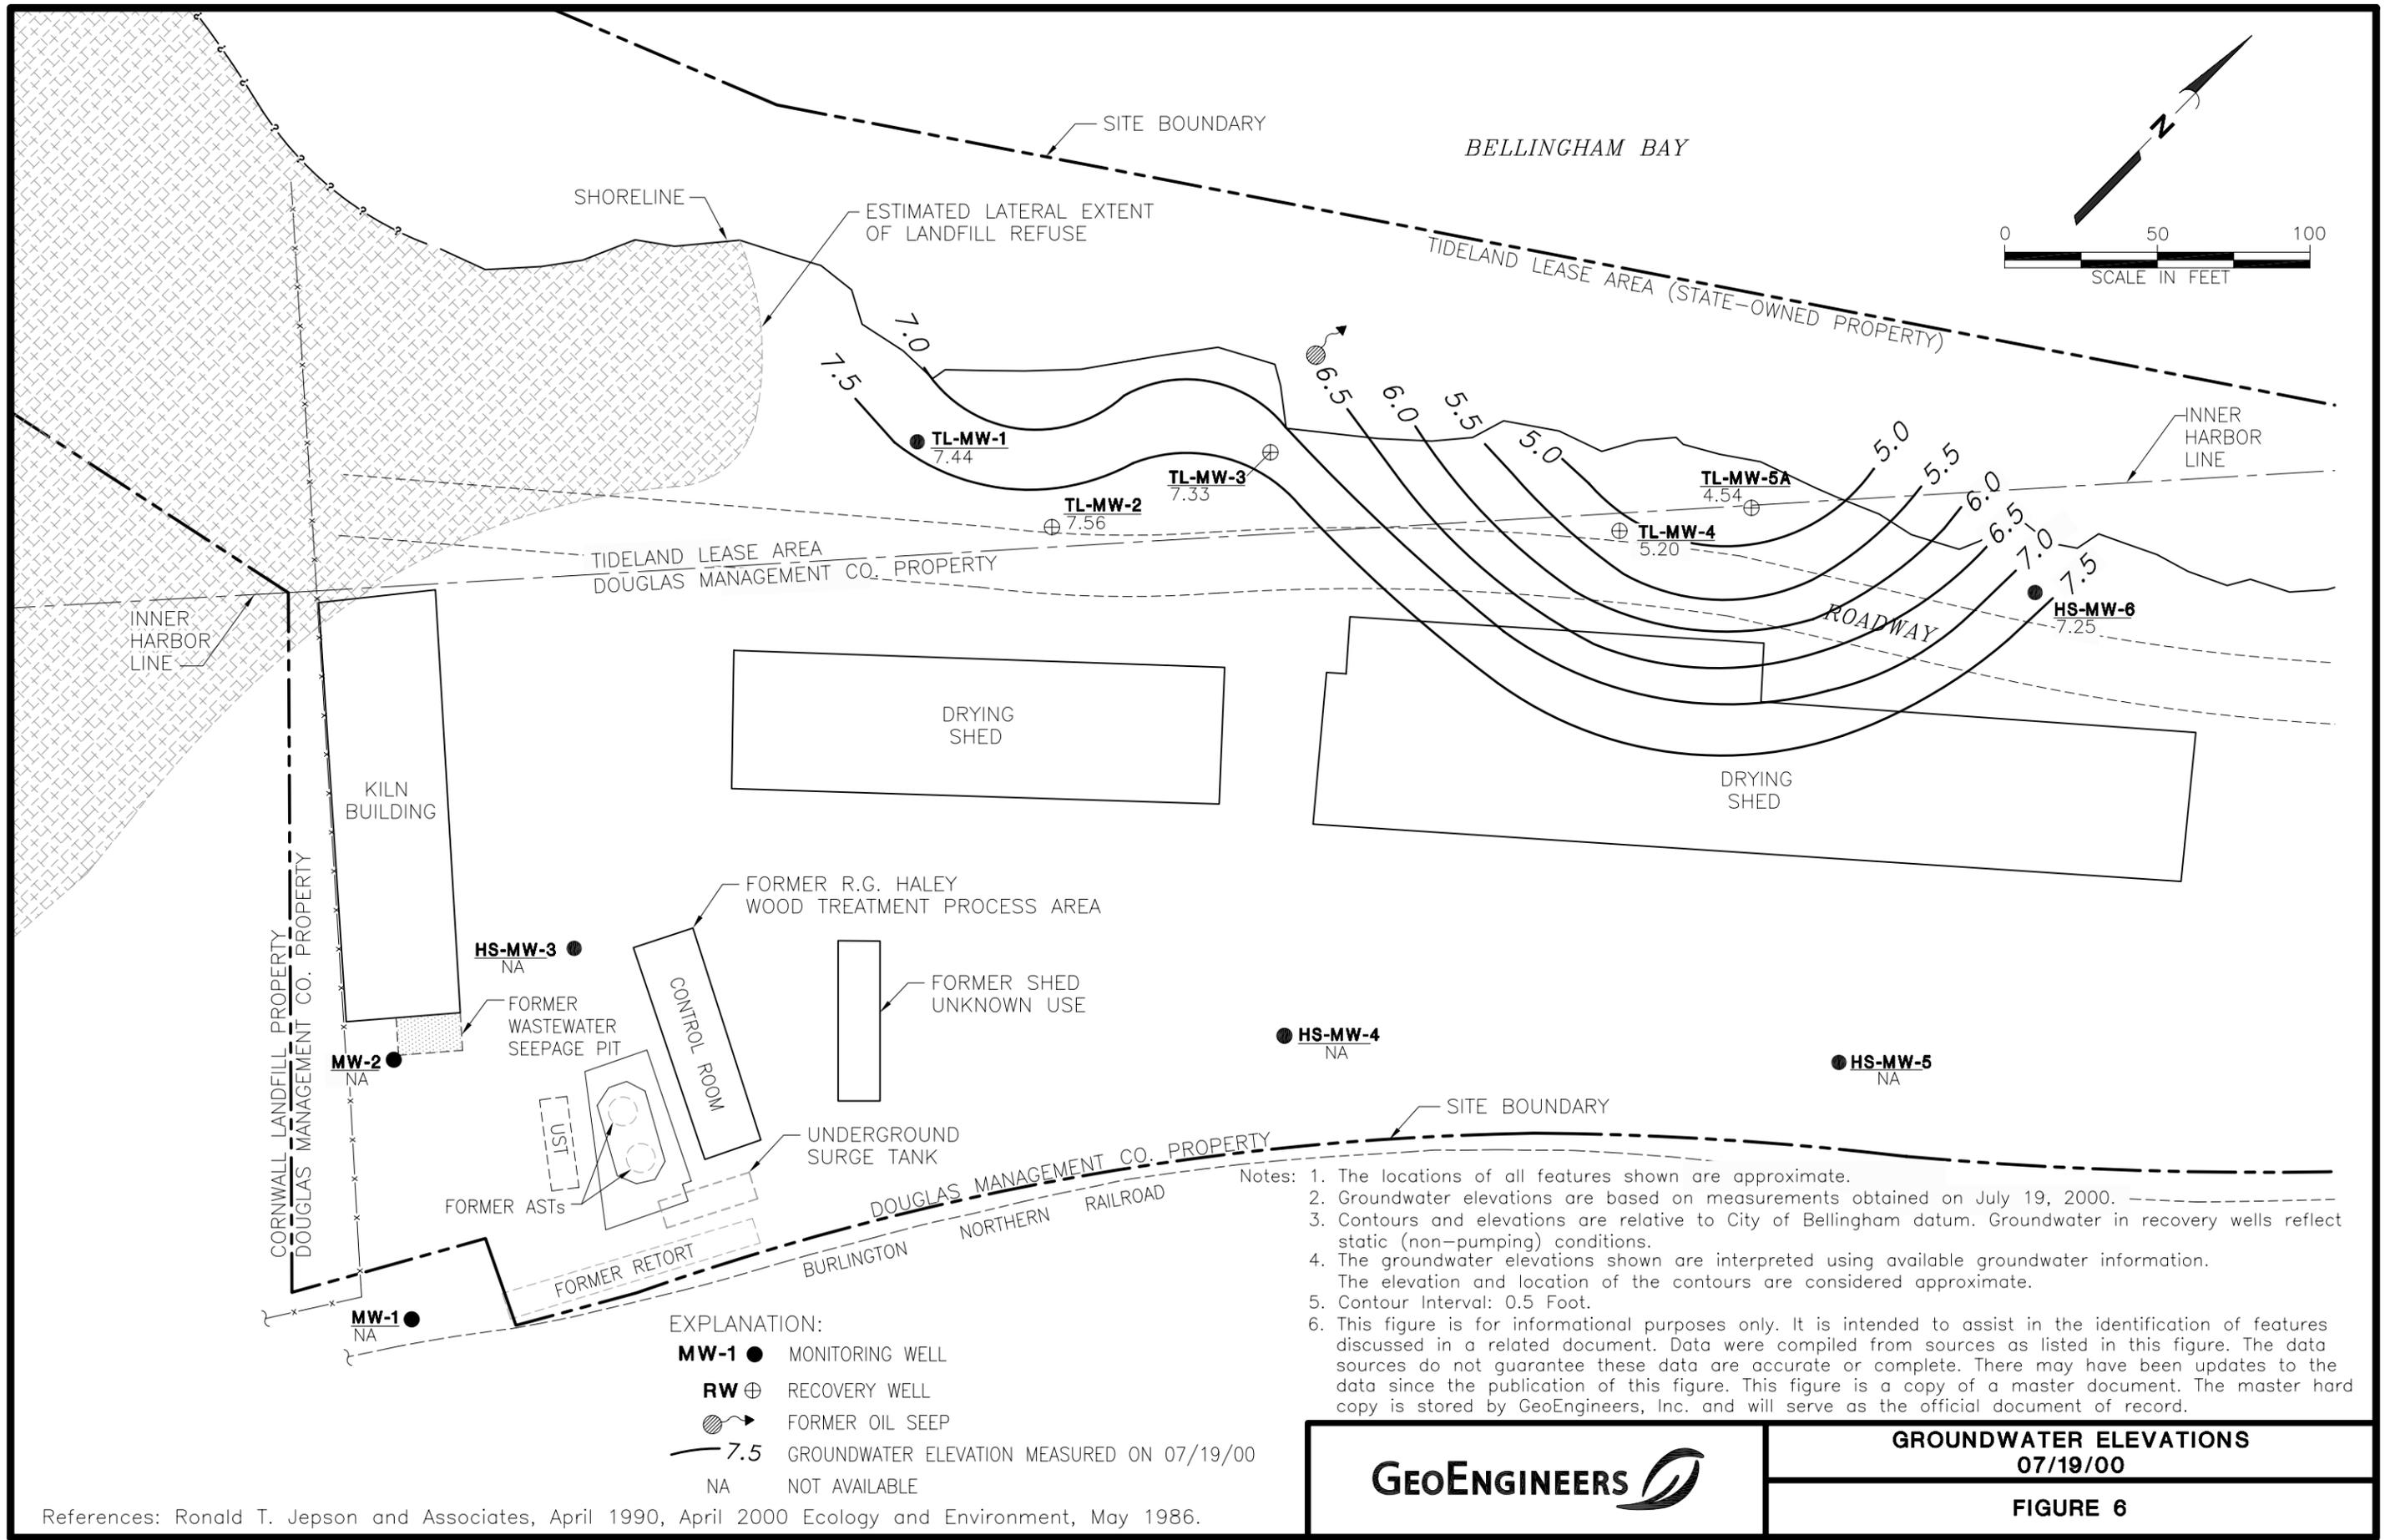
- Notes:
1. The locations of all features shown are approximate.
 2. Groundwater elevations are based on measurements obtained on July 19, 2000.
 3. Contours and elevations are relative to City of Bellingham datum. Groundwater in recovery wells reflect static (non-pumping) conditions.

4. The groundwater elevations shown are interpreted using available groundwater information. The elevation and location of the contours are considered approximate.

5. Contour Interval: 0.5 Foot.
 6. This figure is for informational purposes only. It is intended to assist in the identification of features discussed in a related document. Data were compiled from sources as listed in this figure. The data sources do not guarantee these data are accurate or complete. There may have been updates to the data since the publication of this figure. This figure is a copy of a master document. The master hard copy is stored by GeoEngineers, Inc. and will serve as the official document of record.
